Safe Streets and Roads for All

Safety Action Plan

Prepared by:
E.L. Robinson Engineering Co.
AECOM Technical Services, Inc.

Adopted February 2024

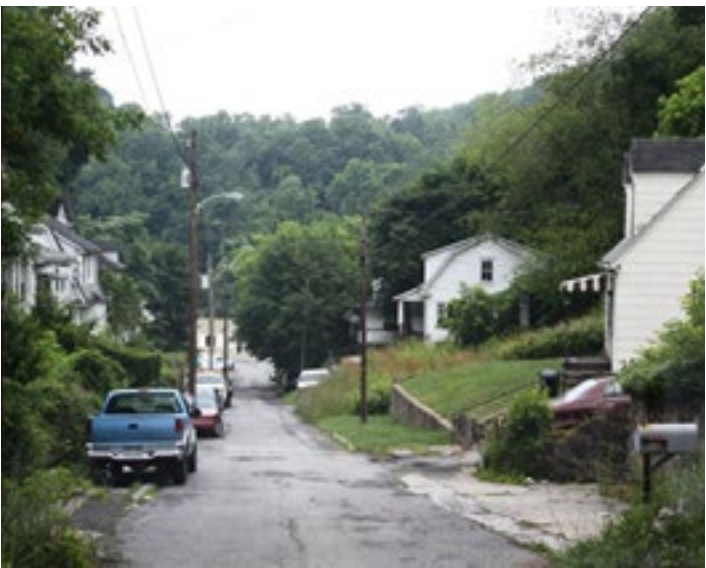
Photograph 12 Ellis Street - "East End" - Showing narrow streets, deteriorated sidewalks, street parking (on the sidewalks)

With the loss of employment opportunities across these four primary economic sectors, Bluefield suffered a significant loss of population to 9,324 as of 2023³. A declining population and local economy have resulted in declining tax revenues. As recently as 2019, the City was forced into “survival mode” in which only essential City services could be maintained. This economic reality meant that over the past five decades, the City has been forced to make hard decisions between essential City services (e.g., public water and sewer or emergency response) and maintaining or improving key components of the transportation infrastructure – such as sidewalks and street lighting (**Photographs 12 and 13**).

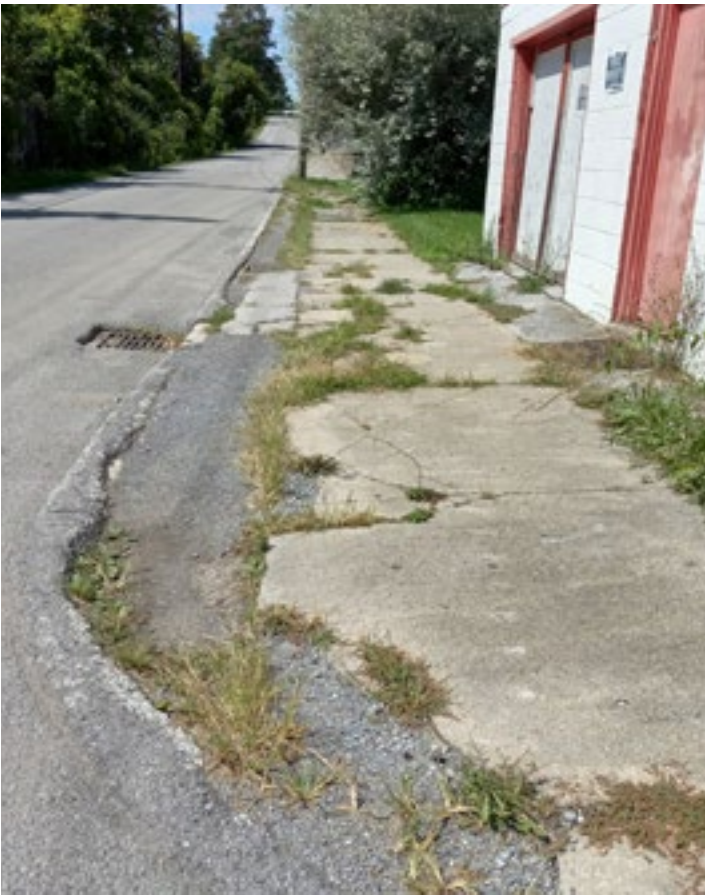
Photograph 13 Henry Street, "East End", showing deteriorated sidewalks

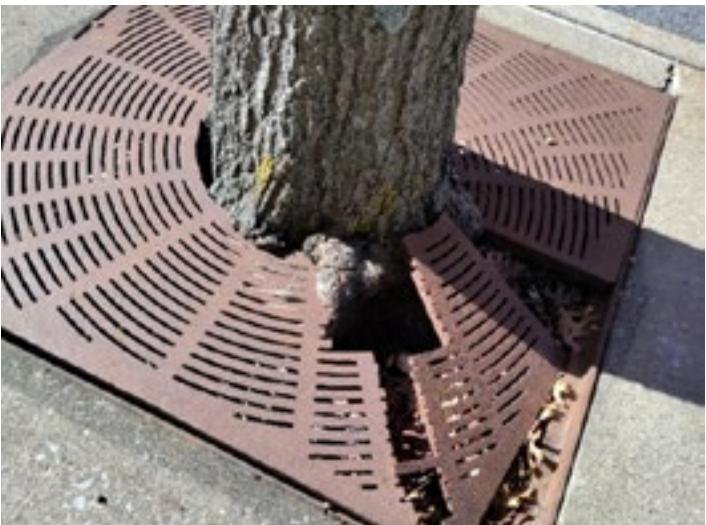
Photograph 24 Overgrown tree roots damage sidewalk and root cage

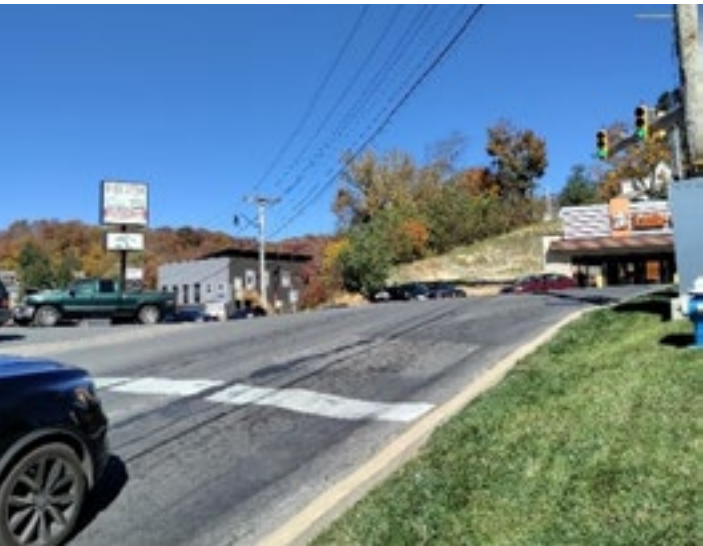
Photograph 29 Sight distance issues travelling east along College Avenue towards Bland Street difficulty seeing traffic from stop bar due to vertical curvature

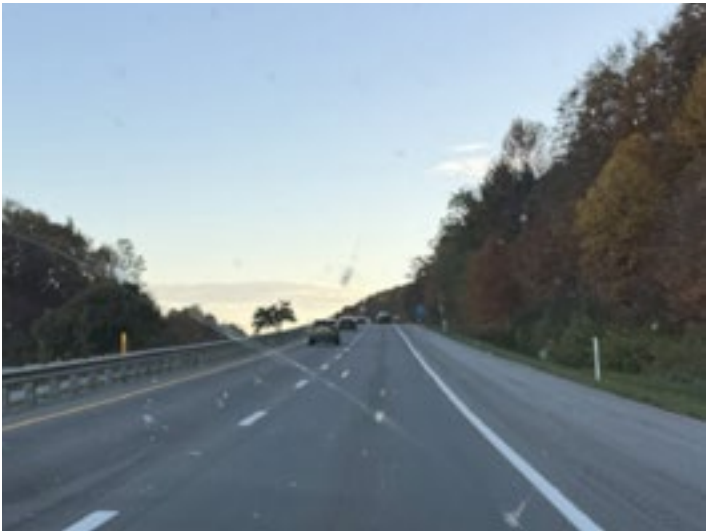
Photograph 35 Eastbound direction of the bifurcated roadway which is elevated above the westbound lane (at left in image)

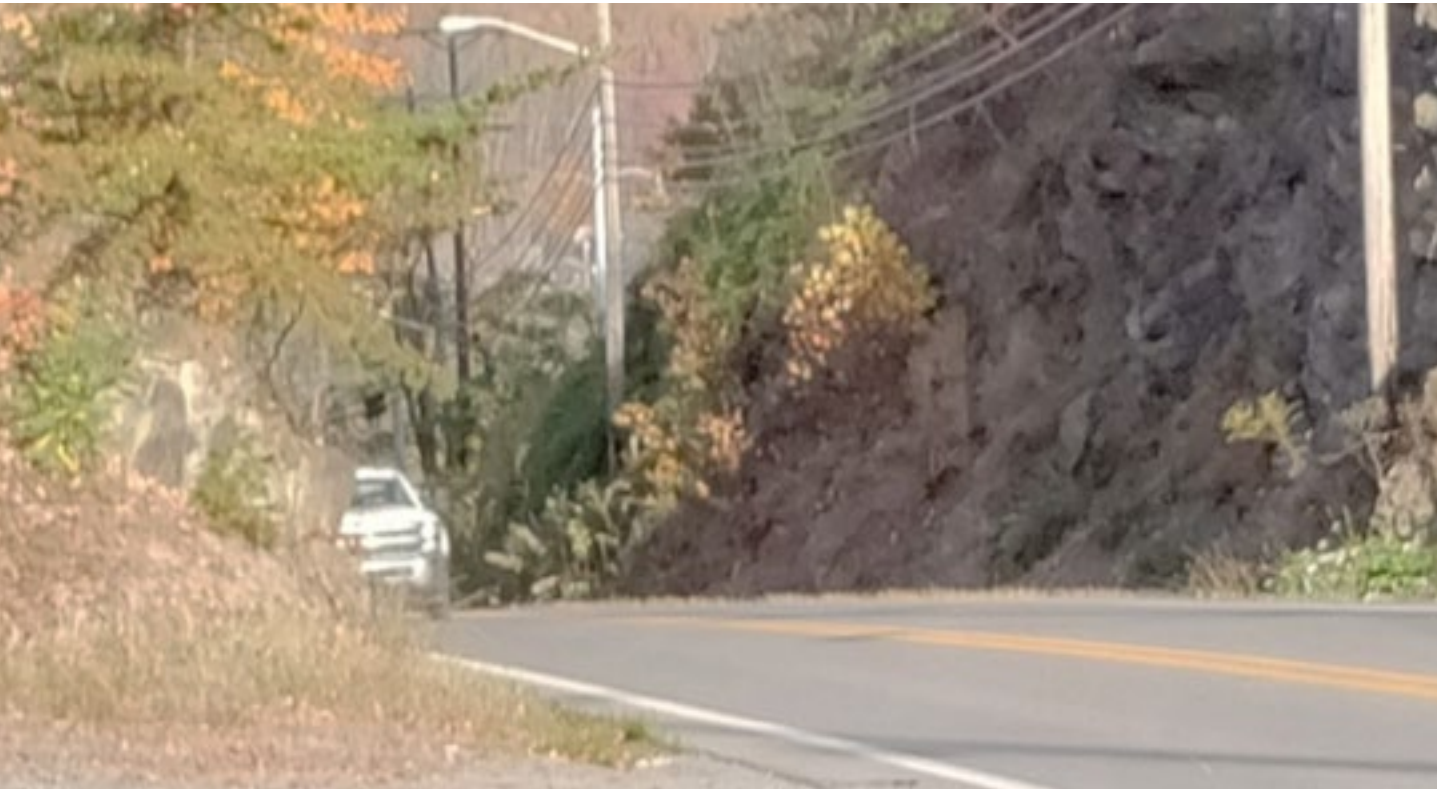
Photograph 46 Narrow rock cut area between BSU dorms and campus along Cherry Street

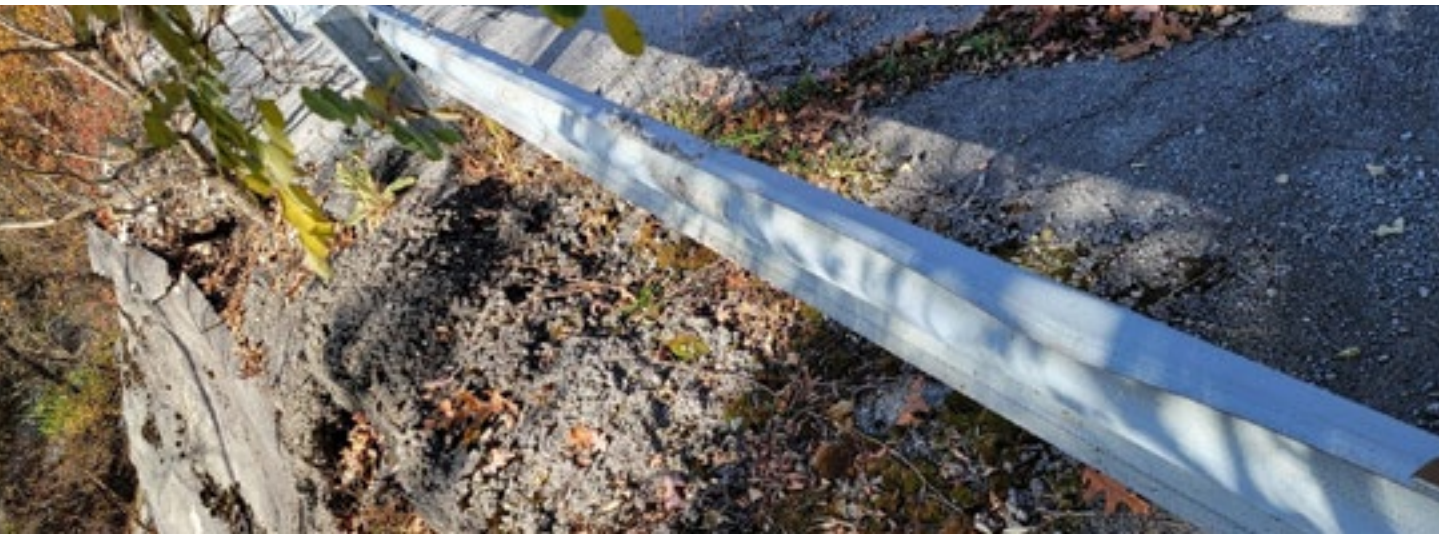
Photograph 49 Deteriorating retaining wall along Orange Street

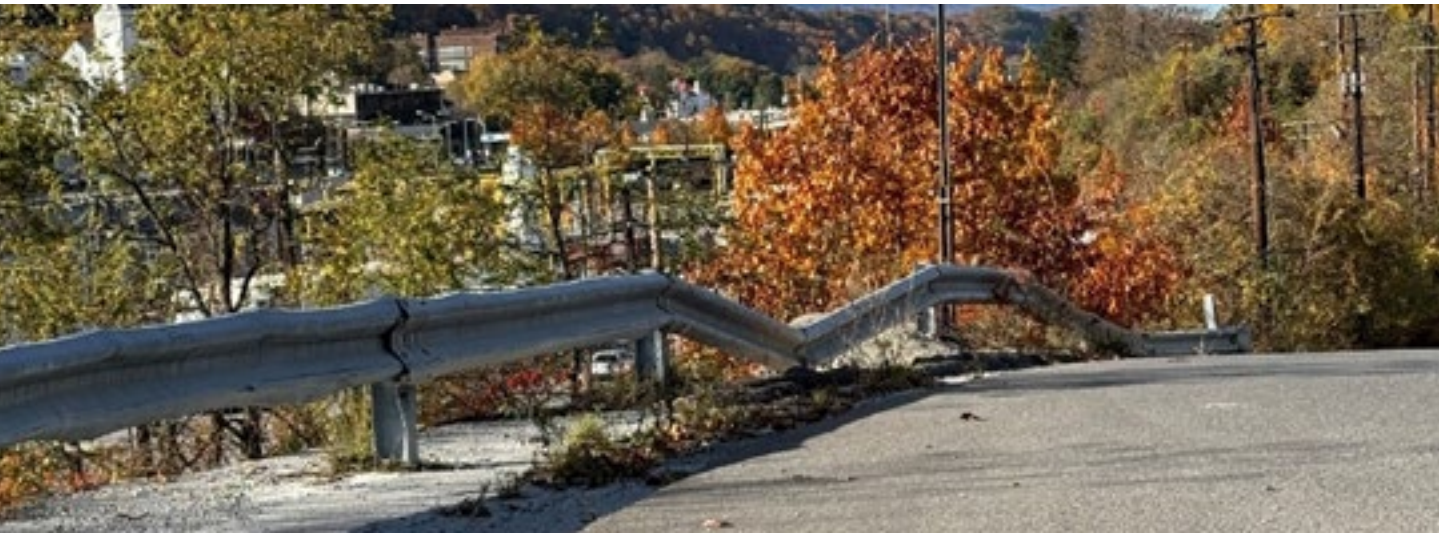
Photograph 50 Damaged barriers along Hardy Street to Orange Street

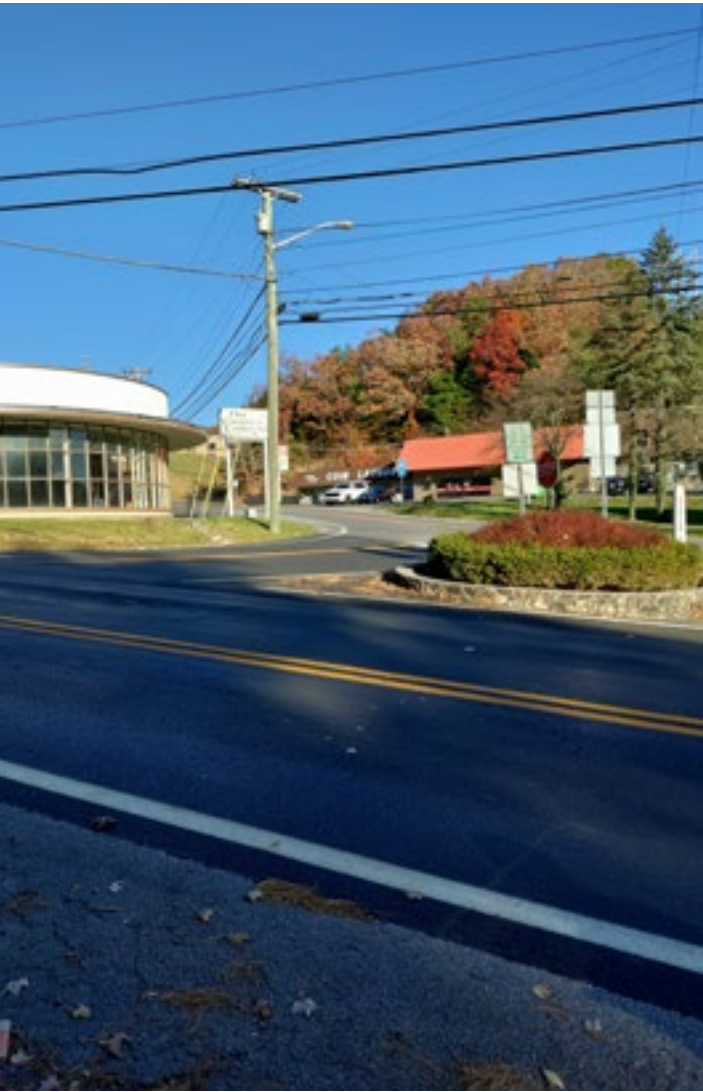
Sight distance is limited at the intersection of Stadium and Cherry Drive due to horizontal and vertical curvature
